Manhole Inspection Summary

Manhole # S23KK_044MH

Insp Date: **8/27/07 10:14 AM**

Location Address: **1212 WHITELOCK ST**

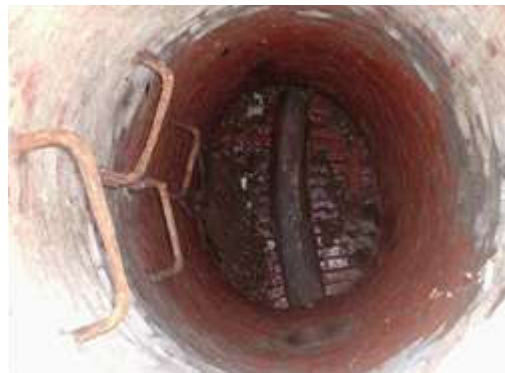
Top View

Corroded steps. Bench debris.

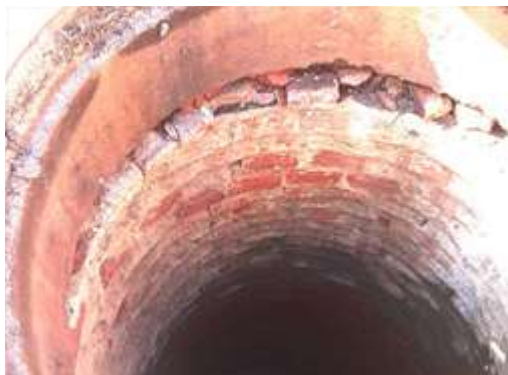
Defect

Frame leaks. Frame offset. Adjustment deterioration, loose brick and infiltration. Barrel infiltration.

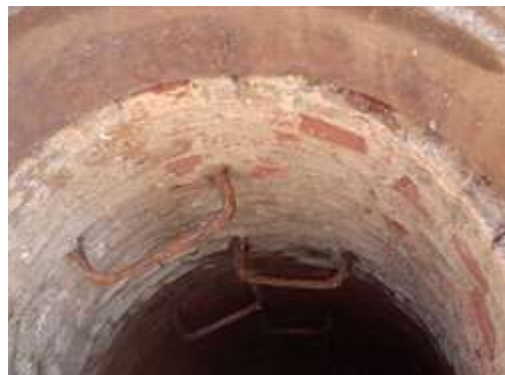
Defect

Frame leaks. Frame offset. Adjustment deterioration and infiltration. Barrel infiltration.

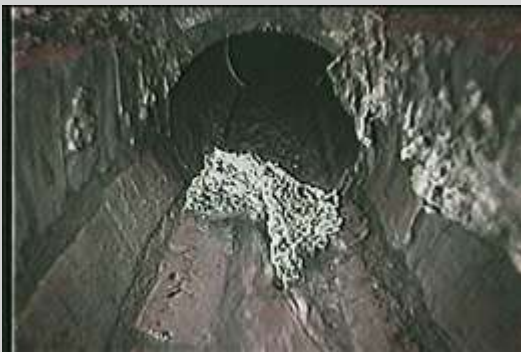
8 in. Circular Gravity Sewer Pipe Out @ 12 O'Clock

Deposits: ☐ None ☐ Mud ☐ Sludge ☒ **Debris** ☐ Grease

Silt Depth: **0** (in.) Deposits Extent: **Light**

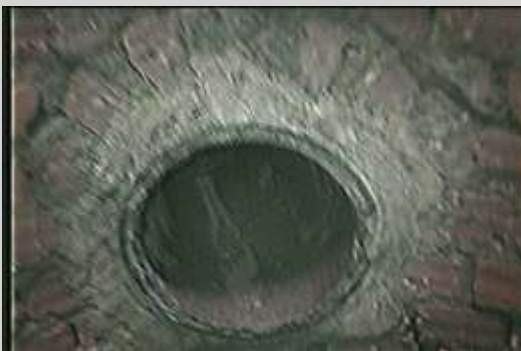
8 in. Circular Gravity Sewer Pipe In @ 6 O'Clock

Deposits: ☒ **None** ☐ Mud ☐ Sludge ☐ Debris ☐ Grease

Infiltration: **None** Pipe Seal Cond: **Unknown**

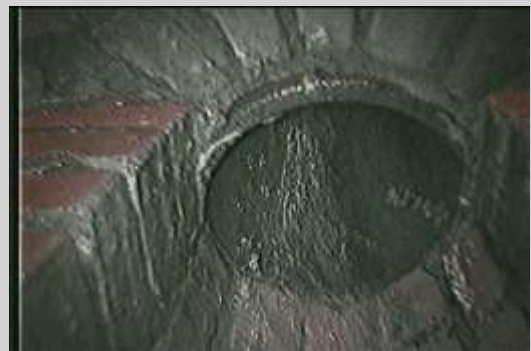
Drop In @ 6 O'Clock

Drop: **Outside** Rod and Bar

Drop Condition: **Open**
